| A tolerance of $\pm 5\%$ applies to all figures Based on tests using 20°C water | name : Tho date : 21.01.10 | <h2>FP 3541</h2> |

FP 3541

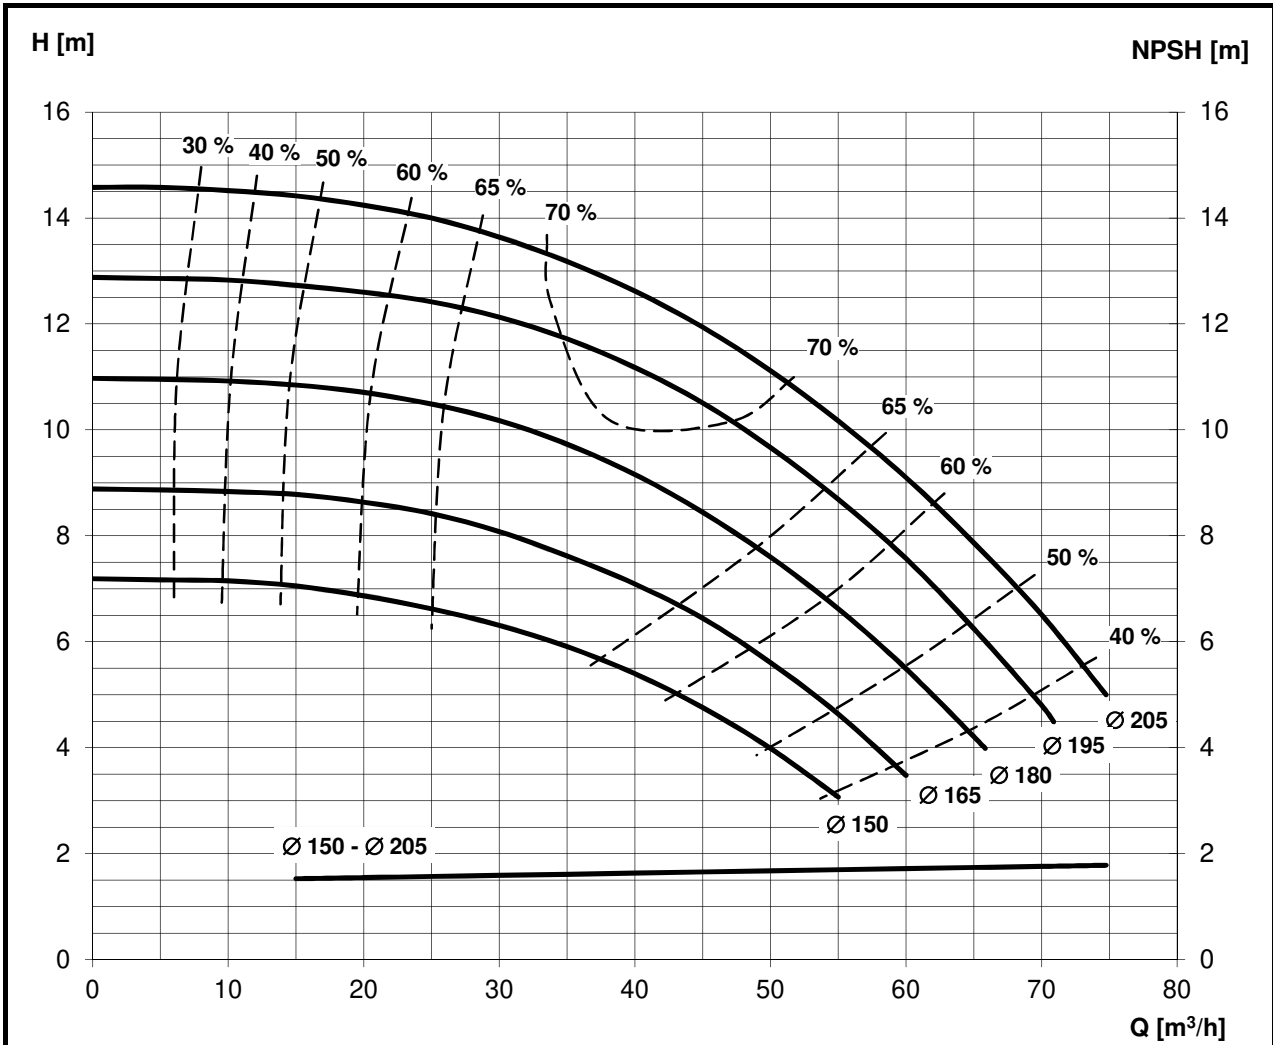
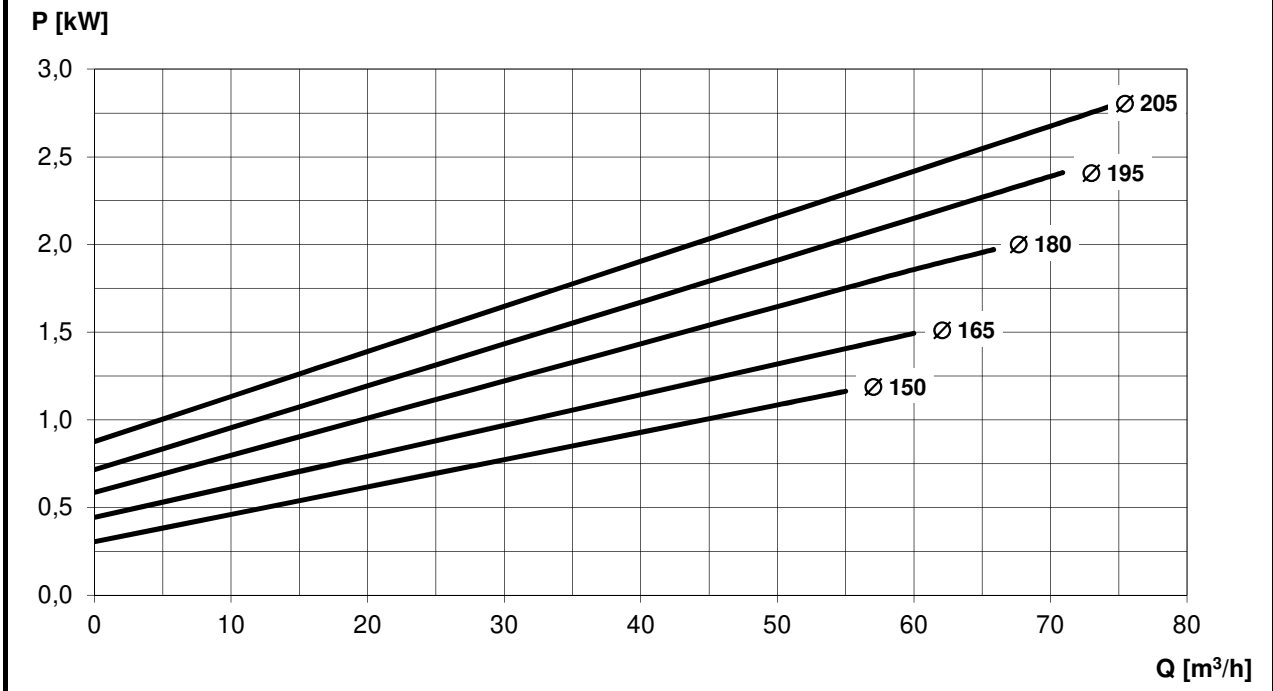
| Inlet: DN 80 Outlet: DN 65 | n = 1450 min⁻¹ | |
